**FIELD OVERSIGHT SUMMARY REPORT**  
**ACS NPL SITE**  
**GRIFFITH, INDIANA**  
**March 29, 1997 - May 31, 1997**

Oversight Summary Report

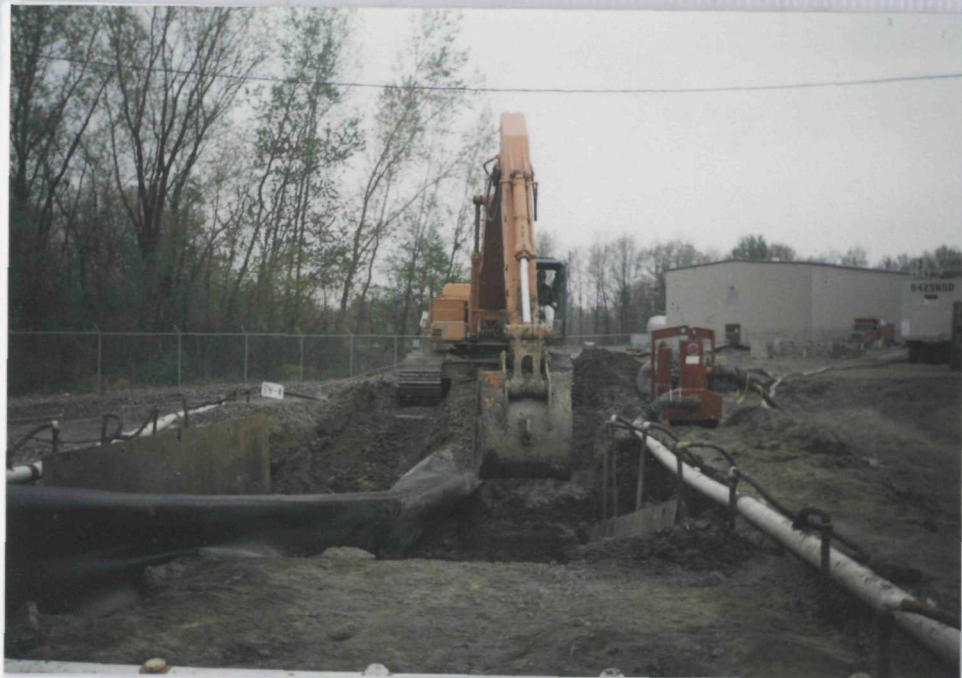
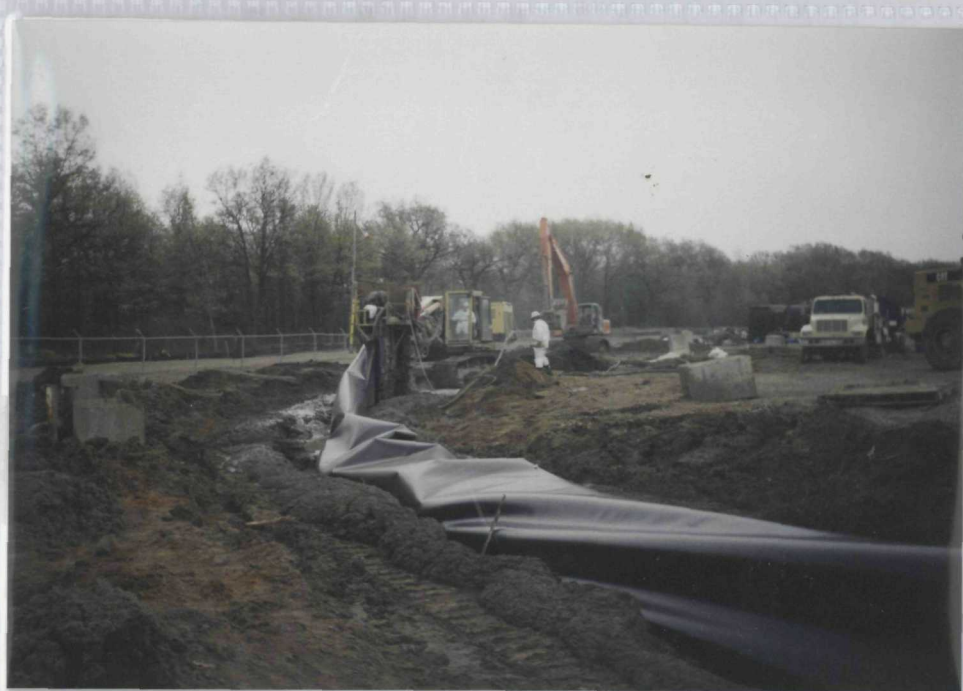
Description: Facing north-east. HTI restoring the sewer line after installing the barrier wall near the south-west corner of the Onsite Containment Area.

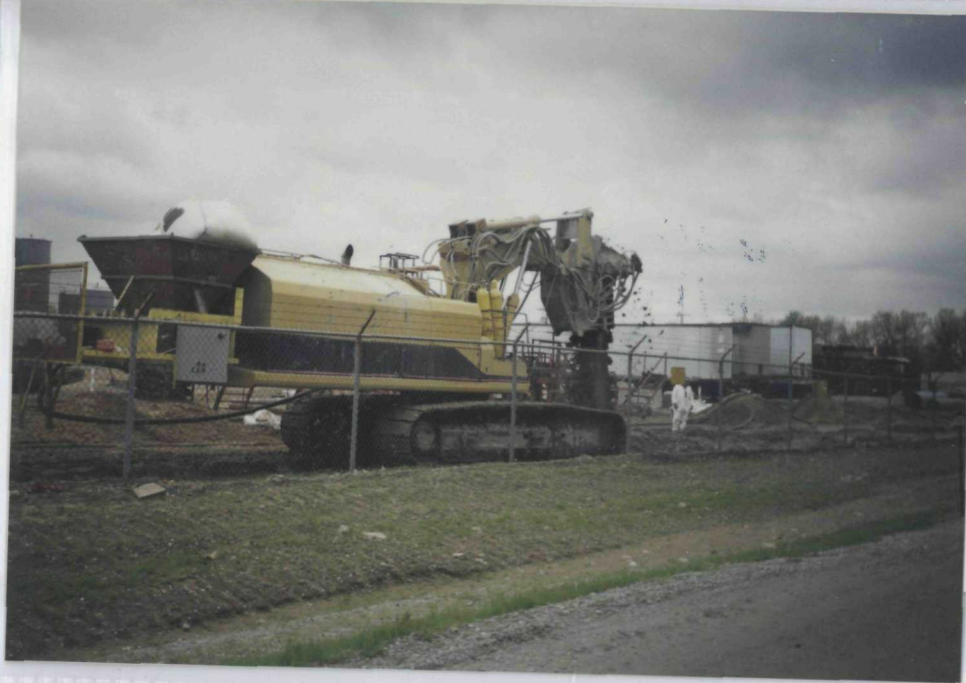
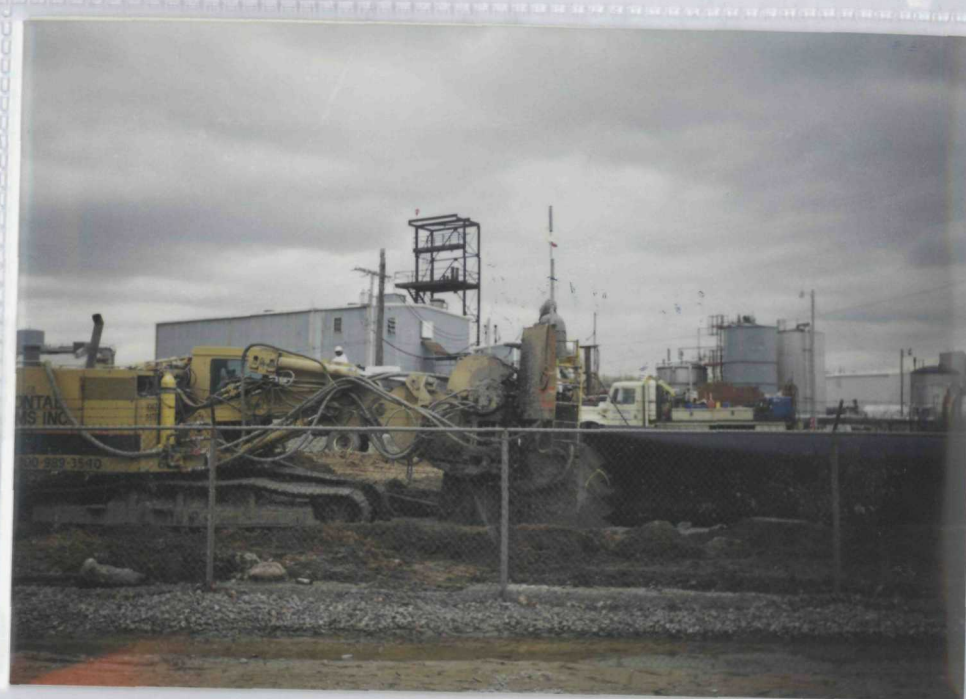
Description: Facing north-east. Using a smaller trenching machine, HTI installing the barrier wall near the north-west corner of the barrier wall alignment in the Onsite Containment Area and beginning to install the barrier wall along the northern leg of the revised barrier wall alignment.

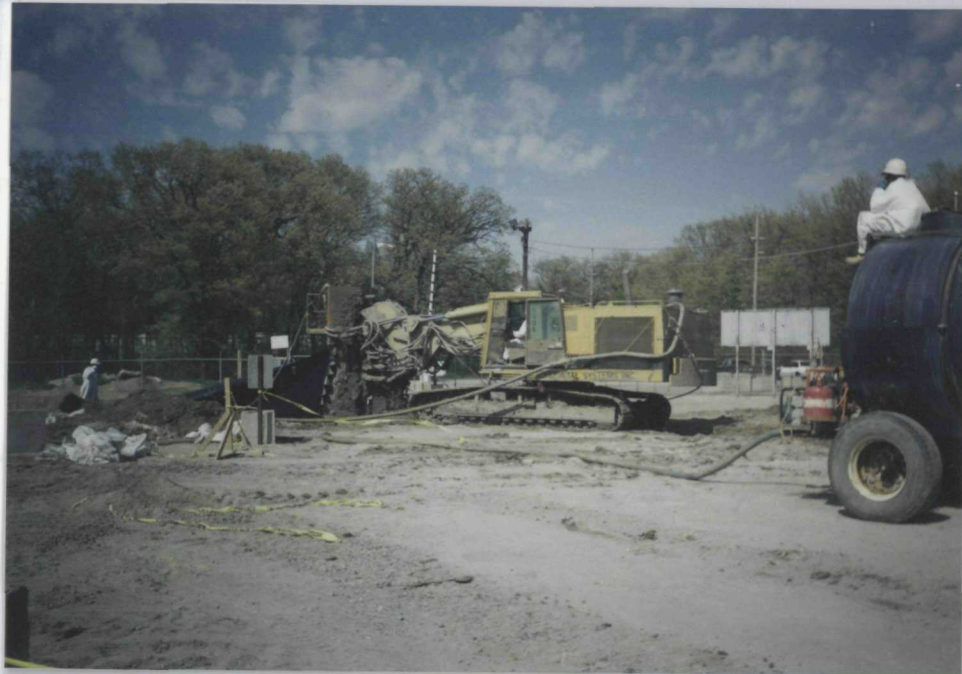
Site: American Chemical Services, Inc. RD/ERA  
 Proj. #: 71670.600  
 Roll: 7 Photo #: 49  
 Date: 05-17-97 Time: 1300  
 Photographer: Ashok Rupani  
 Description: Facing north-east. Using a smaller trenching machine, HTI installing barrier wall along the northern leg of the revised barrier wall alignment.

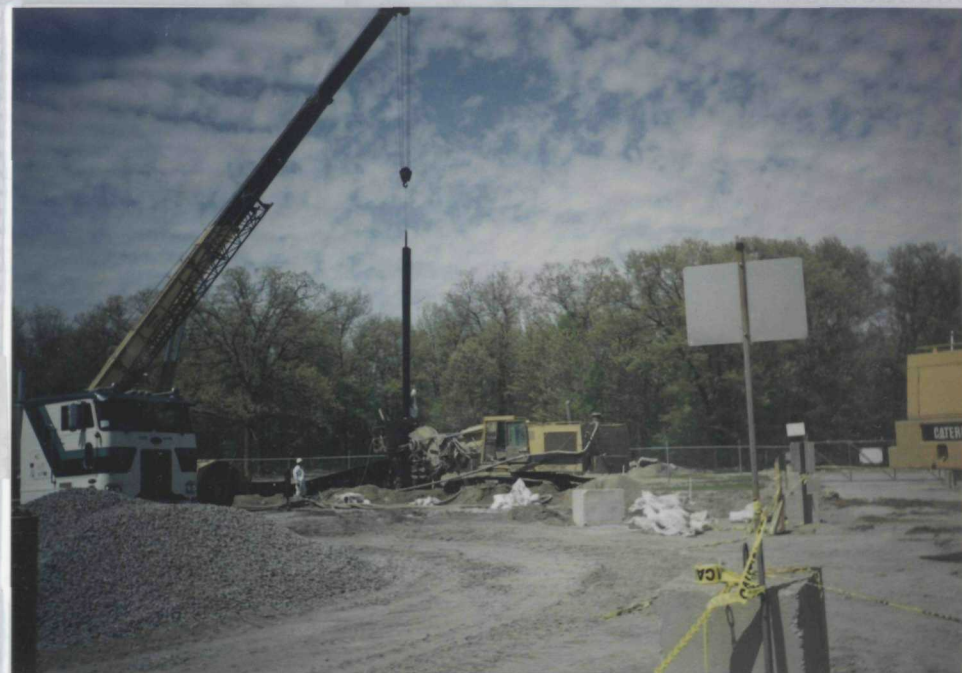
Site: American Chemical Services, Inc. RD/ERA  
 Proj. #: 71670.600  
 Roll: 7 Photo #: 50  
 Date: 05-17-97 Time: 1400  
 Photographer: Ashok Rupani  
 Description: Facing north-east. HTI making a joint during barrier wall installation along the northern leg of the revised barrier wall alignment.

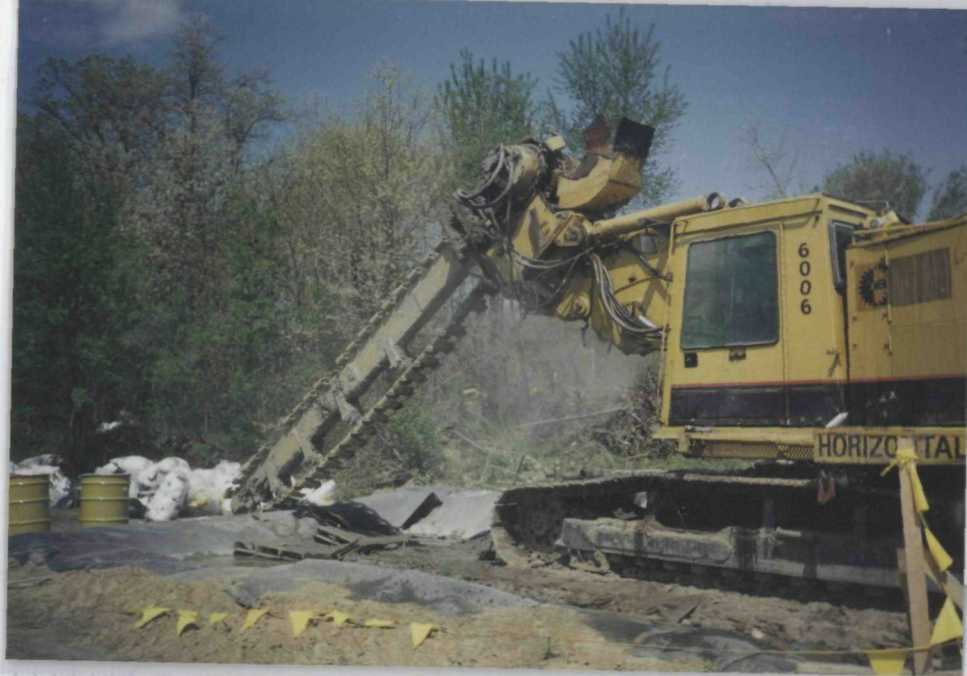
Site: American Chemical Services, Inc. RD/ERA  
 Proj. #: 71670.600  
 Roll: 7 Photo #: 51  
 Date: 05-20-97 Time: 1440  
 Photographer: Ashok Rupani  
 Description: Facing east. HTI decontaminating the smaller trenching machine before demobilizing it from the site.

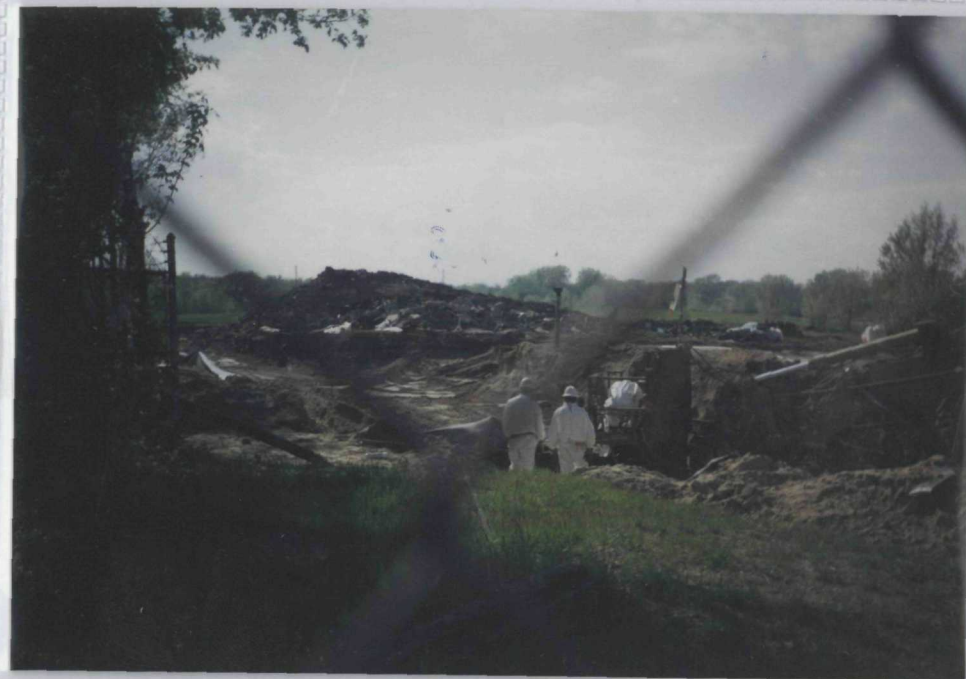
Site: American Chemical Services, Inc. RD/ERA  
 Proj. #: 71670.600  
 Roll: 7 Photo #: 52  
 Date: 05-20-97 Time: 1615  
 Photographer: Ashok Rupani  
 Description: Facing west. HTI resumes barrier wall installation near the south-east corner of the barrier wall alignment near Station 8+50 in the Offsite Containment Area.

On May 20, 1997, after making needed repairs, HTI began barrier wall installation with the bigger trenching machine. HTI initiated the installation activities at Station 8+50 near the south-east corner of the Offsite Containment Area and proceeded north. North of the Station 7+00, this process would constitute second of the two-pass process. HTI continued to encounter similar problems as described earlier. However, by the end of this reporting period, HTI had managed to install three (3) HDPE panels to Station 5+00 with one gap after the first two HDPE panels.

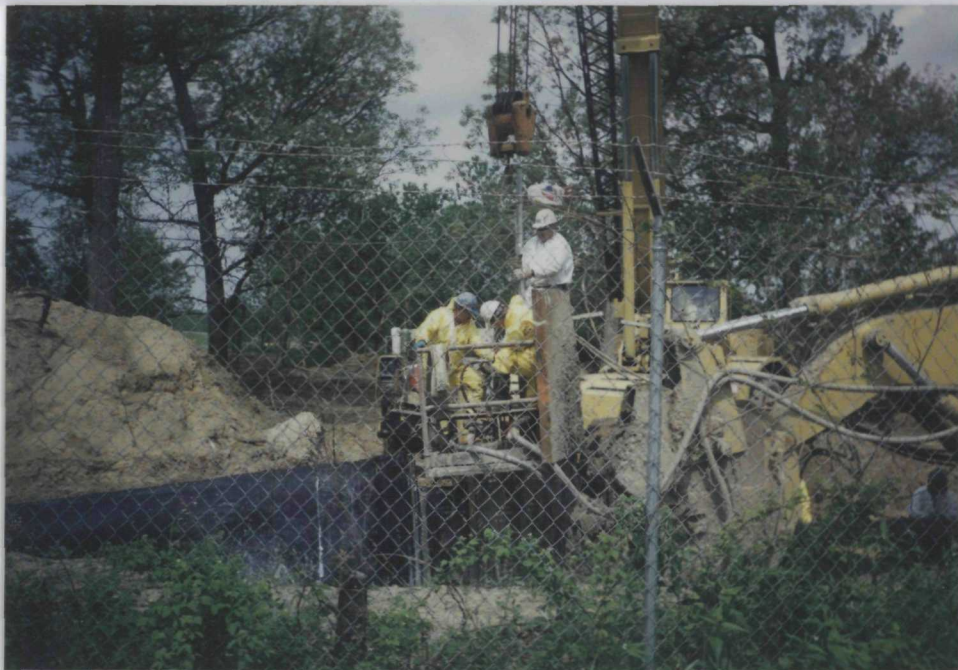
Description: Facing south-west. HTI installed the first HDPE panel starting at Station 8+50 near the south-east corner of the barrier wall alignment in the Offsite Containment Area.

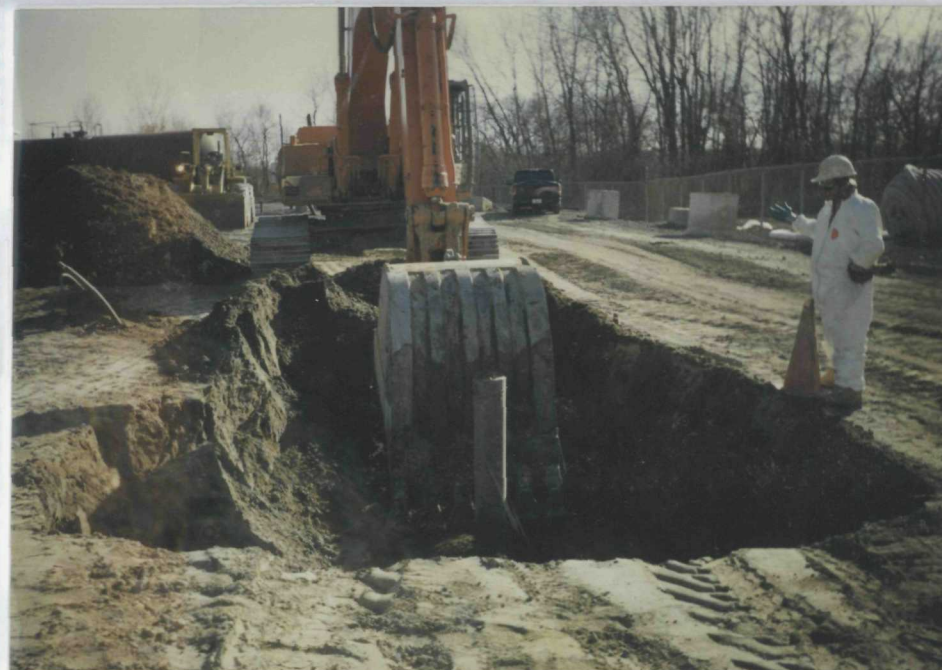
Description: Facing south. HTI excavating to install manhole at Extraction Trench 10.

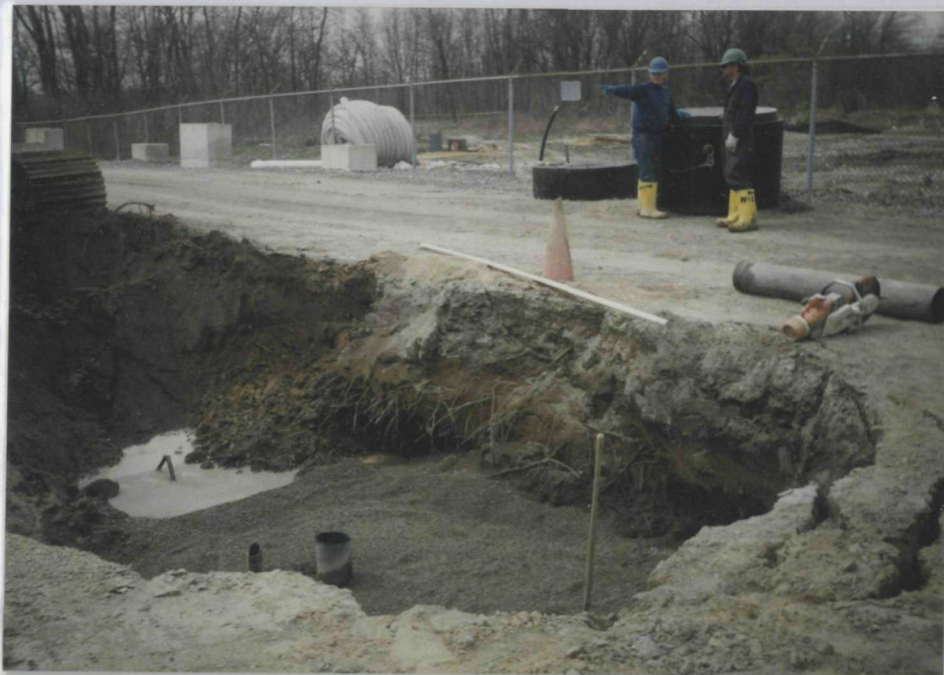
Site: American Chemical Services, Inc. RD/ERA  
 Proj. #: 71670.600  
 Roll: 2 Photo #: 57  
 Date: 04-04-97 Time: 1045  
 Photographer: Ashok Rupani  
 Description: Facing south-west. HTI placing gravel at the bottom of the excavation to install manhole at Extraction Trench 10.

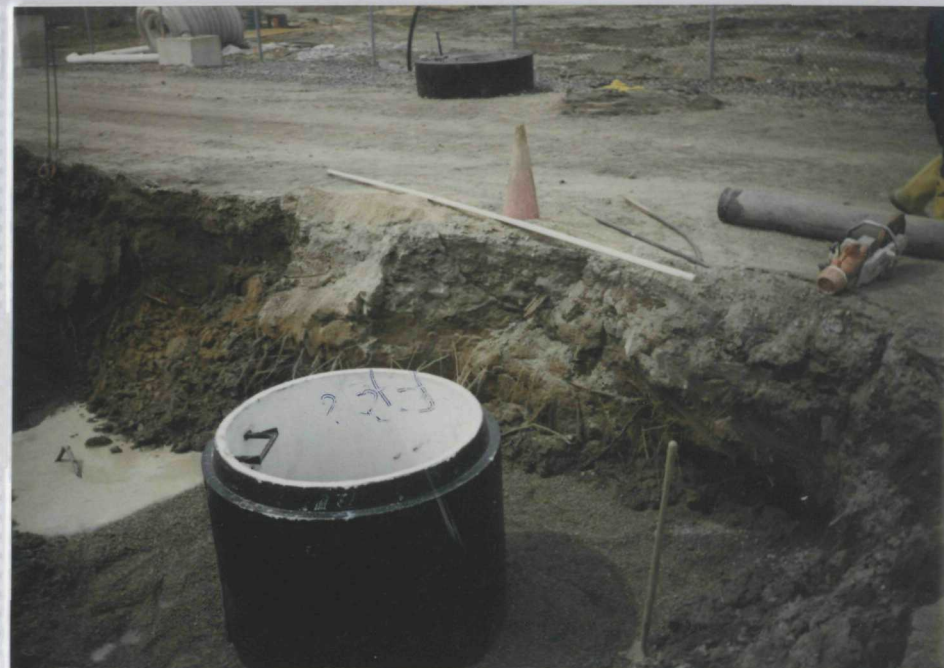
Site: American Chemical Services, Inc. RD/ERA  
 Proj. #: 71670.600  
 Roll: 2 Photo #: 58  
 Date: 04-04-97 Time: 1130  
 Photographer: Ashok Rupani  
 Description: Facing south-west. HTI set the manhole in place at Extraction Trench 10.

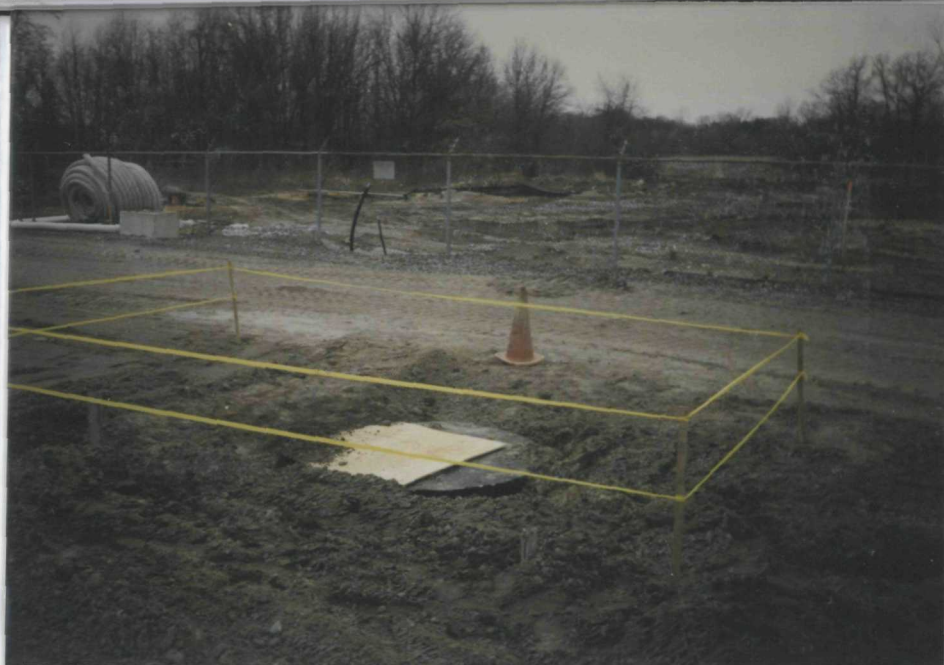
Site: American Chemical Services, Inc. RD/ERA  
 Proj. #: 71670.600  
 Roll: 2 Photo #: 59  
 Date: 04-04-97 Time: 1645  
 Photographer: Ashok Rupani  
 Description: Facing south-west. HTI completed the manhole installation at Extraction Trench 10 except the mechanical and electrical hook-ups.

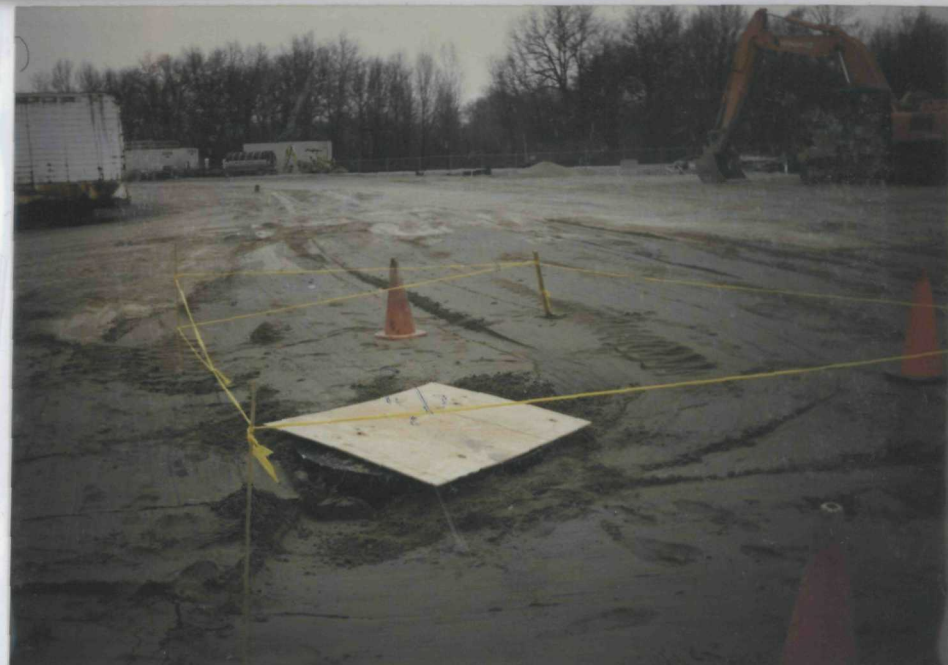
Site: American Chemical Services, Inc. RD/ERA  
 Proj. #: 71670.600  
 Roll: 2 Photo #: 60  
 Date: 04-04-97 Time: 1650  
 Photographer: Ashok Rupani  
 Description: Facing west. HTI completed the manhole installation at Extraction Trench 18 except the mechanical and electrical hook-ups.

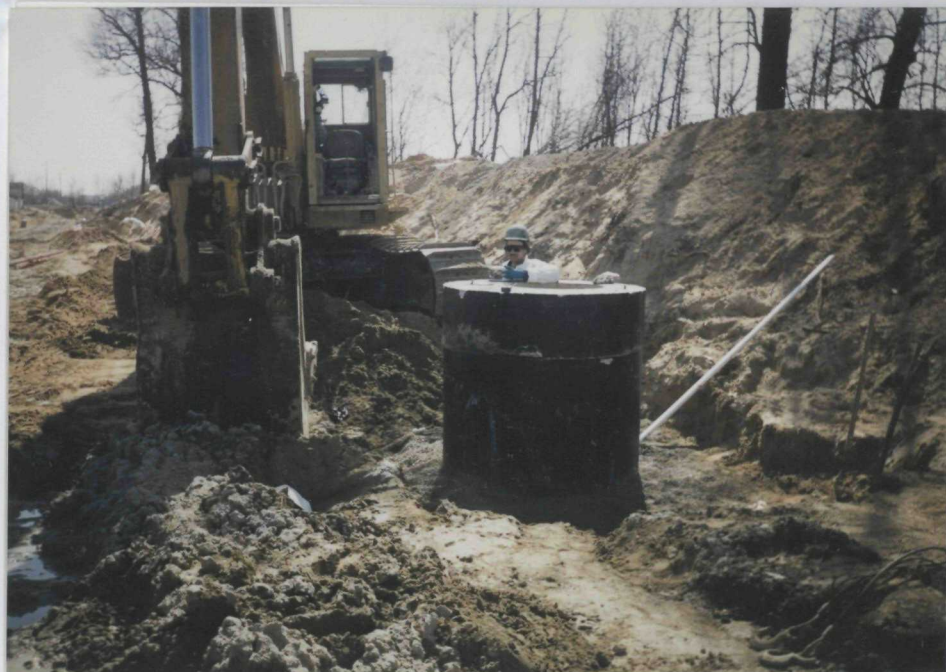
Site: American Chemical Services, Inc. RD/ERA  
 Proj. #: 71670.600  
 Roll: 4 Photo #: 61  
 Date: 04-14-97 Time: 1435  
 Photographer: Ashok Rupani  
 Description: Facing south. HTI installing a manhole at Extraction Trench 16.

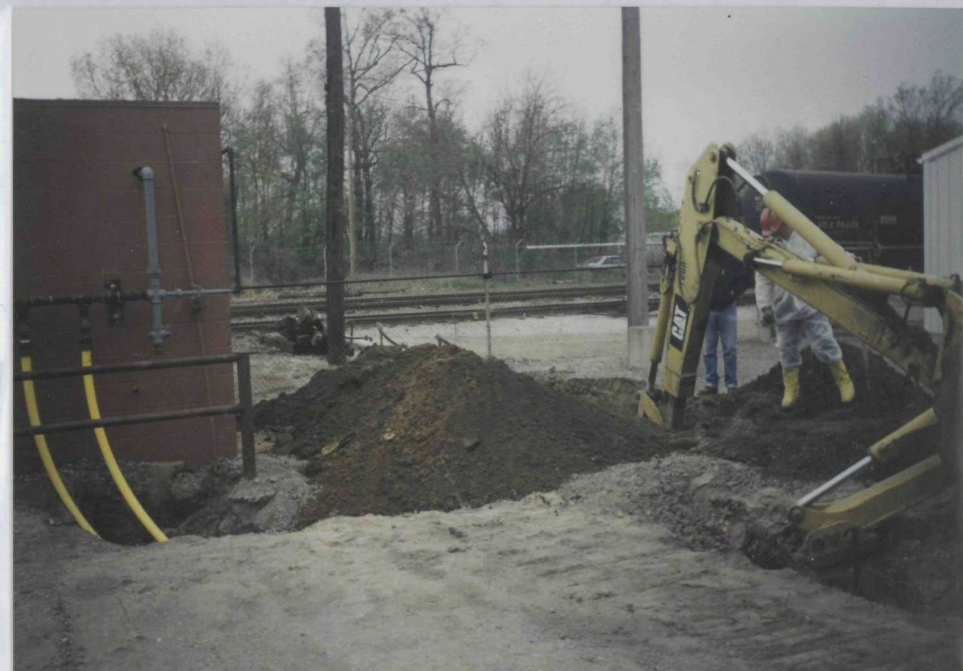
Site: American Chemical Services, Inc. RD/ERA  
 Proj. #: 71670.600  
 Roll: 6 Photo #: 62  
 Date: 05-13-97 Time: 1115  
 Photographer: Ashok Rupani  
 Description: Facing south-west. Youngs begins to install the BWES conveyance piping (a 2-inch HDPE influent line and a 1-inch HDPE air line) near the south-east corner of the Onsite Containment Area.

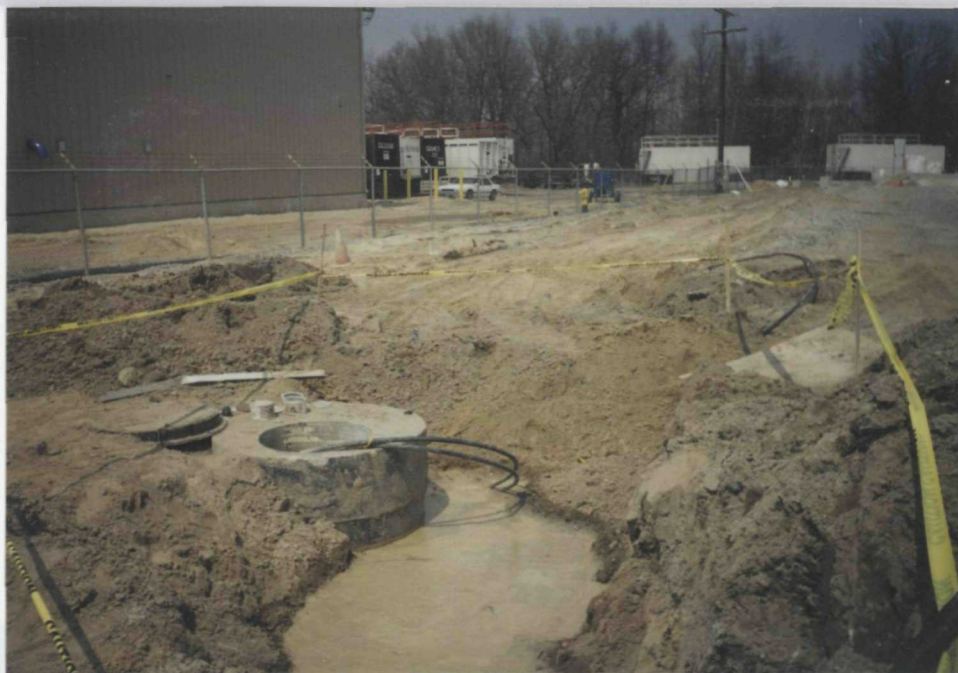
Site: American Chemical Services, Inc. RD/ERA  
 Proj. #: 71670.600  
 Roll: 5 Photo #: 67  
 Date: 04-28-97 Time: 1405  
 Photographer: Ashok Rupani  
 Description: Facing north-west. HTI completes the mechanical and electrical hook-ups at Extraction Trench 10.

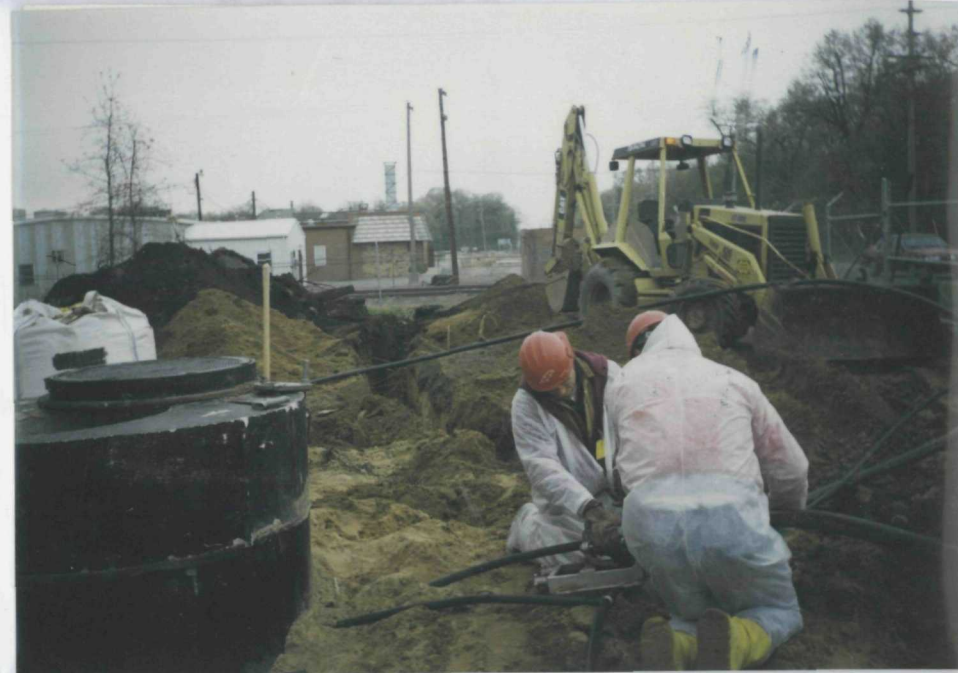
Site: American Chemical Services, Inc. RD/ERA  
 Proj. #: 71670.600  
 Roll: 6 Photo #: 68  
 Date: 05-13-97 Time: 0935  
 Photographer: Ashok Rupani  
 Description: Facing north. Youngs connecting the BWES conveyance piping to the sump at Extraction Trench 16 and installing the BWES conveyance piping from this sump to the fence just south of the railroad tracks. This portion of the BWES conveyance piping had not been completed earlier.

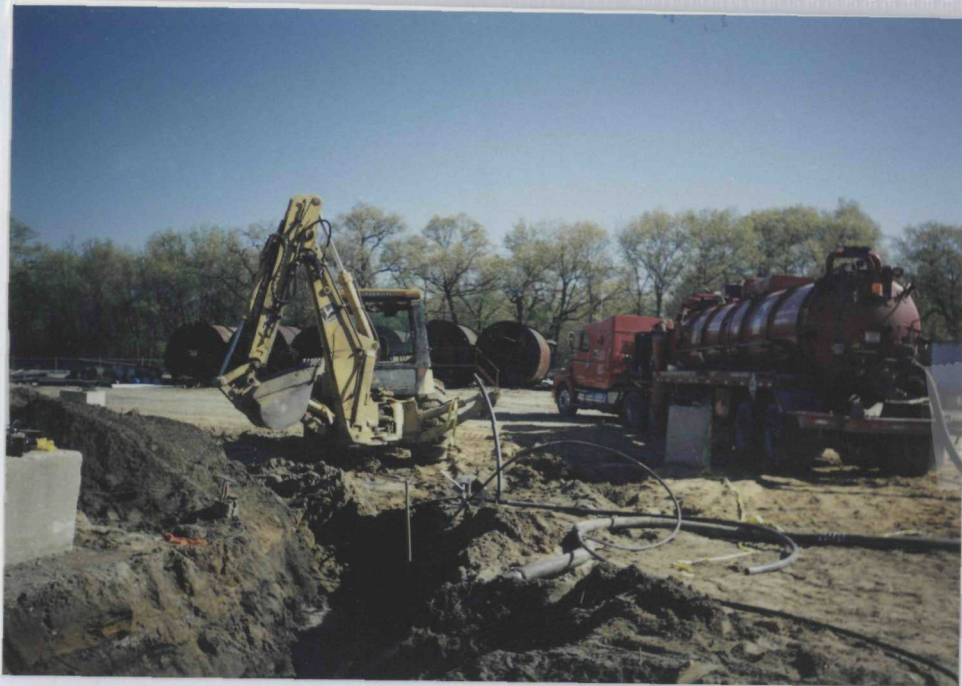
Site: American Chemical Services, Inc. RD/ERA  
 Proj. #: 71670.600  
 Roll: 7 Photo #: 73  
 Date: 05-21-97 Time: 0850  
 Photographer: Ashok Rupani  
 Description: Facing north. Youngs connecting the BWES conveyance piping to the sump at Extraction Trench 18.

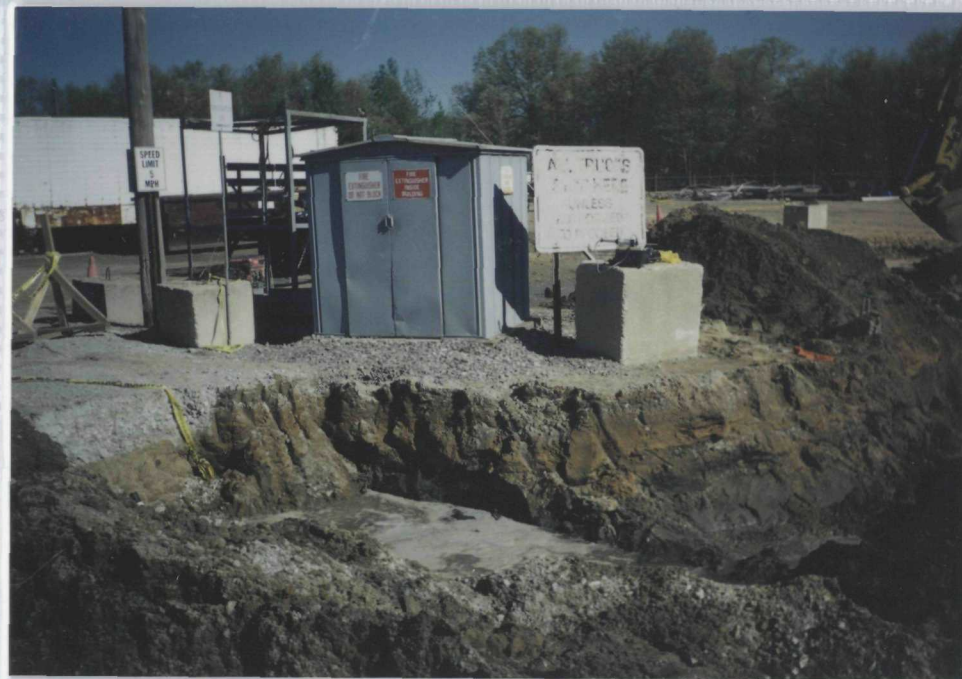
Site: American Chemical Services, Inc. RD/ERA  
 Proj. #: 71670.600  
 Roll: 7 Photo #: 74  
 Date: 05-21-97 Time: 0850  
 Photographer: Ashok Rupani  
 Description: Facing north-west. Youngs conducting de-watering activities while connecting the BWES conveyance piping to the sump at Extraction Trench 18.

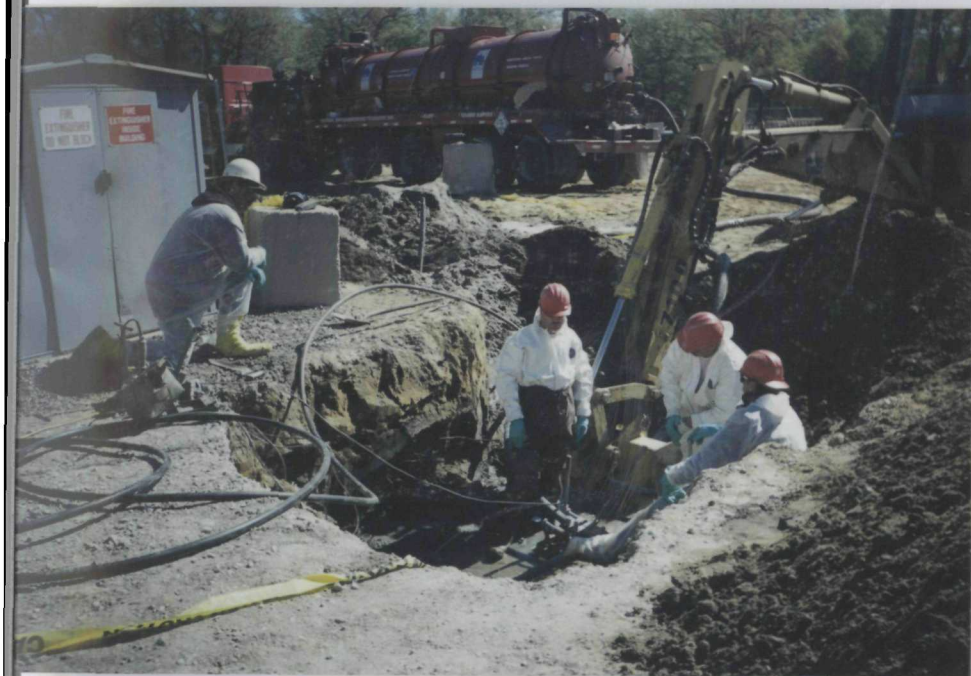
Site: American Chemical Services, Inc. RD/ERA  
 Proj. #: 71670.600  
 Roll: 7 Photo #: 75  
 Date: 05-21-97 Time: 0935  
 Photographer: Ashok Rupani  
 Description: Facing north-west. Youngs connecting the BWES conveyance piping to the sump at Extraction Trench 18.

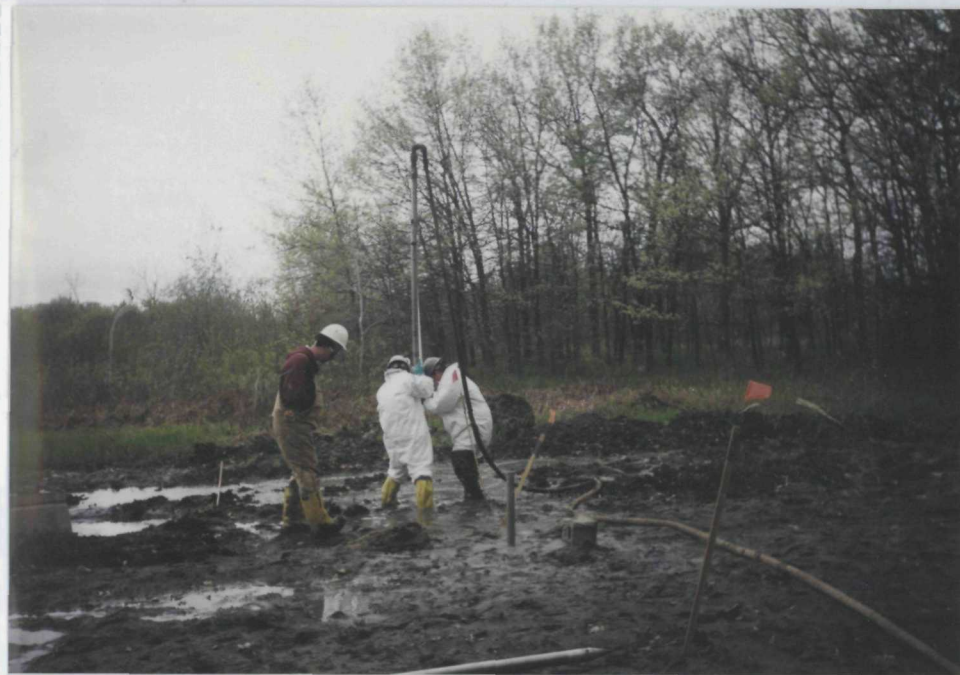
Site: American Chemical Services, Inc. RD/ERA  
 Proj. #: 71670.600  
 Roll: 6 Photo #: 76  
 Date: 05-15-97 Time: 1050  
 Photographer: Ashok Rupani  
 Description: Facing west. Midwest De-watering Co. installing the PGCS monitoring piezometer P-87.

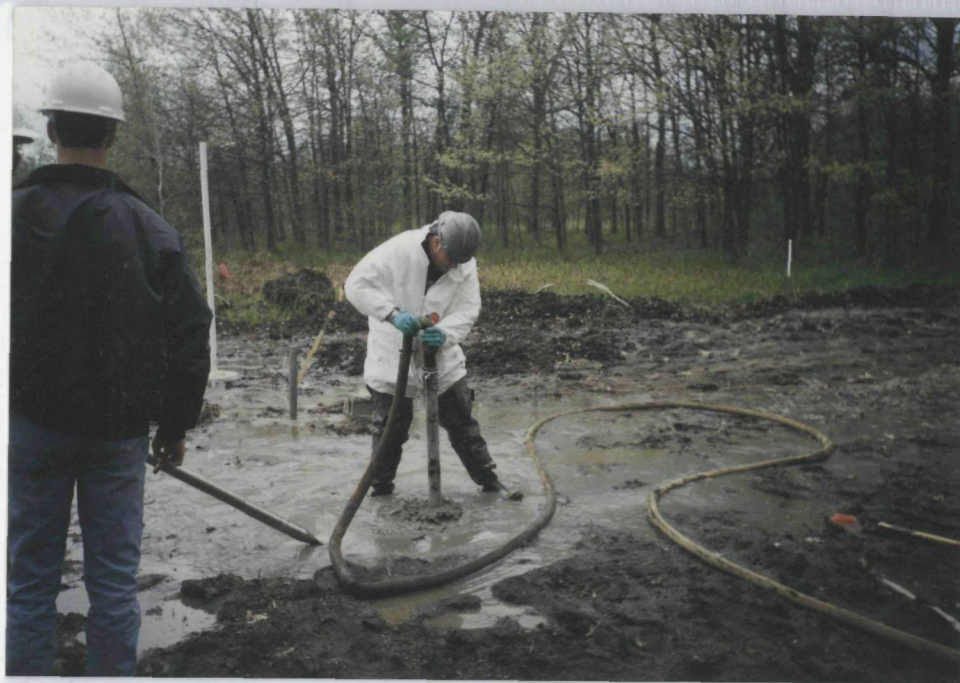
Site: American Chemical Services, Inc. RD/ERA  
 Proj. #: 71670.600  
 Roll: 6 Photo #: 77  
 Date: 05-15-97 Time: 1050  
 Photographer: Ashok Rupani  
 Description: Facing west. Midwest De-watering Co. installing the  
 PGCS monitoring piezometer P-89.

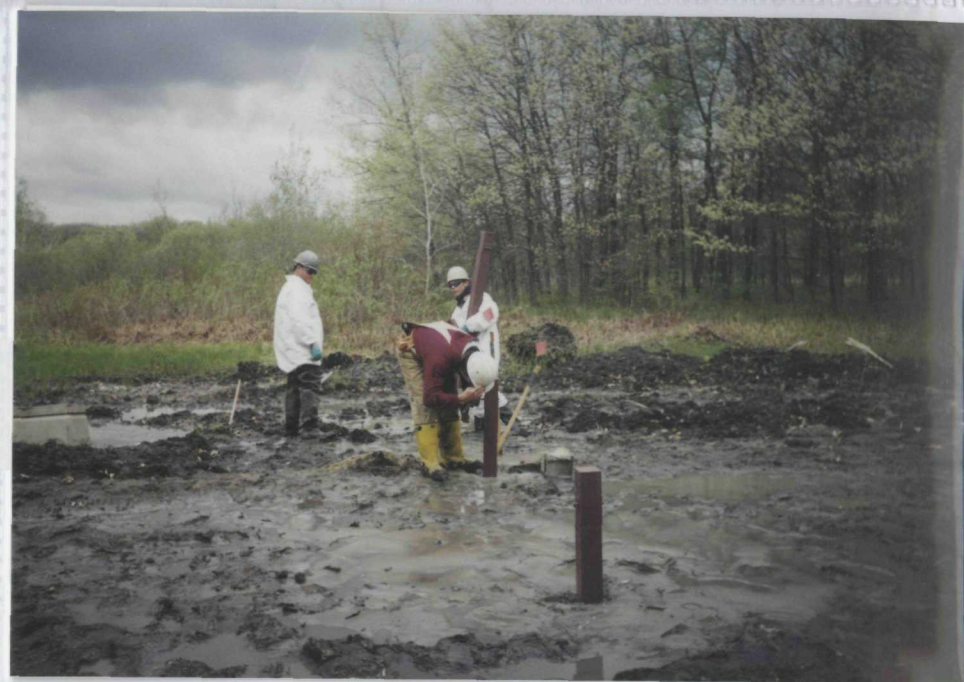
Site: American Chemical Services, Inc. RD/ERA  
 Proj. #: 71670.600  
 Roll: 6 Photo #: 78  
 Date: 05-15-97 Time: 1050  
 Photographer: Ashok Rupani  
 Description: Facing west. Midwest De-watering Co. installing surface  
 casing for the PGCS piezometer P-88.

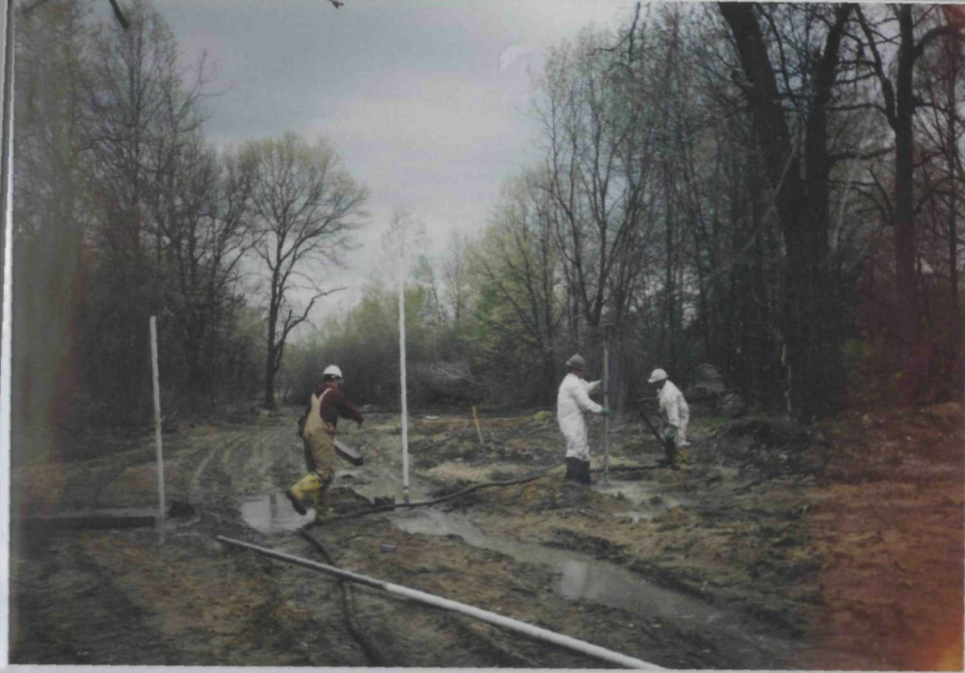
Site: American Chemical Services, Inc. RD/ERA  
 Proj. #: 71670.600  
 Roll: 6 Photo #: 81  
 Date: 05-15-97 Time: 1500  
 Photographer: Ashok Rupani  
 Description: Facing west. Midwest De-watering Co. installing the  
 PGCS monitoring piezometer P-83.

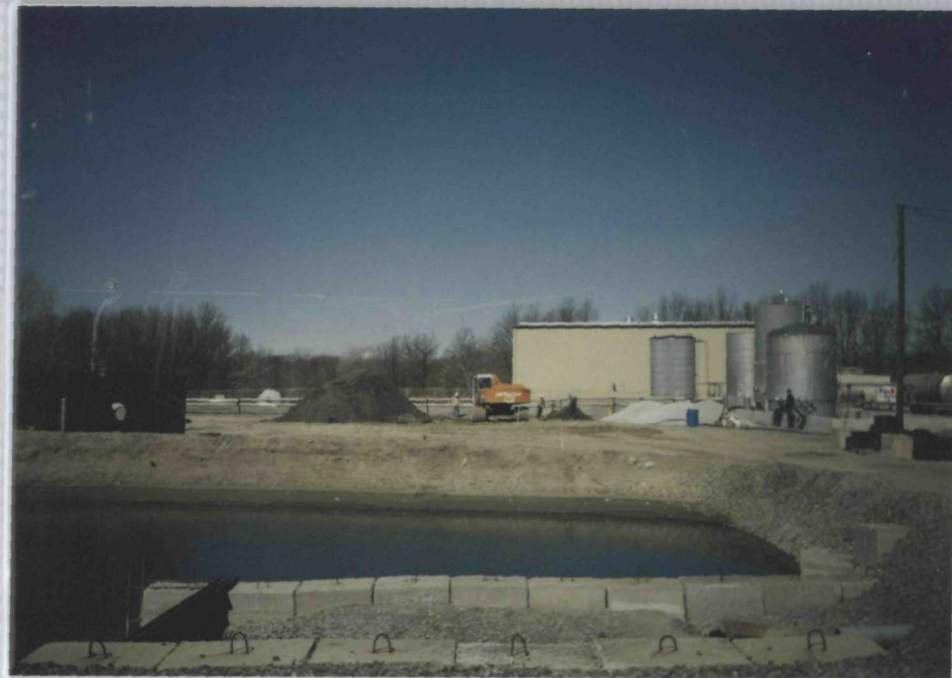
Site: American Chemical Services, Inc. RD/ERA  
 Proj. #: 71670.600  
 Roll: 1 Photo #: 82  
 Date: 04-01-97 Time: 0930  
 Photographer: Ashok Rupani  
 Description: Facing west. Construction of ACS stormwater collection  
 system in progress. Midwest Material Services of  
 Hammond, Indiana, was the contractor for the project.

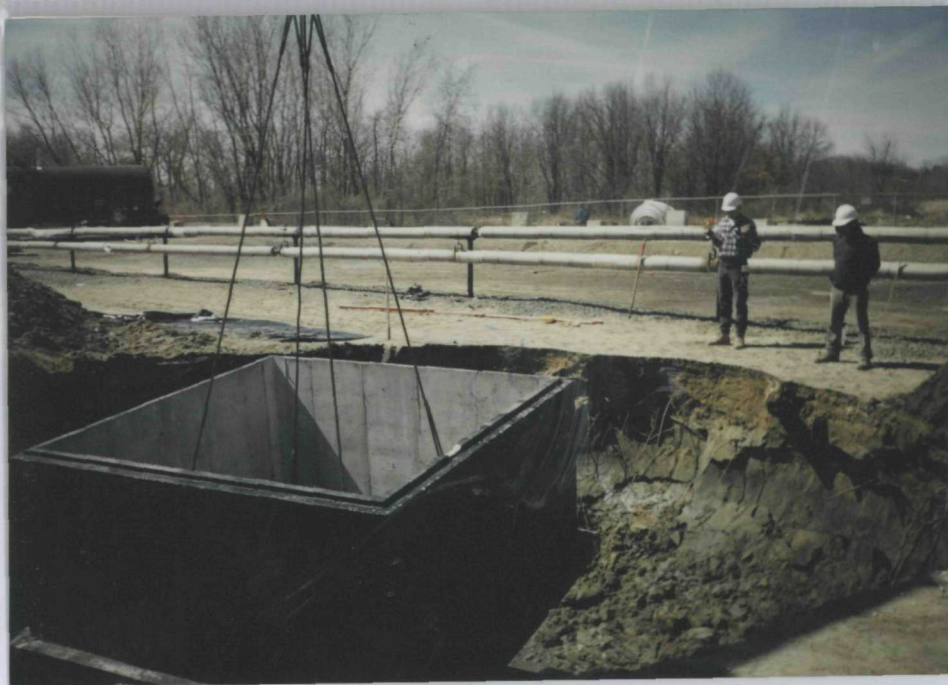
Description: Facing south-west. Setting the bottom half of the western settling tank in place.

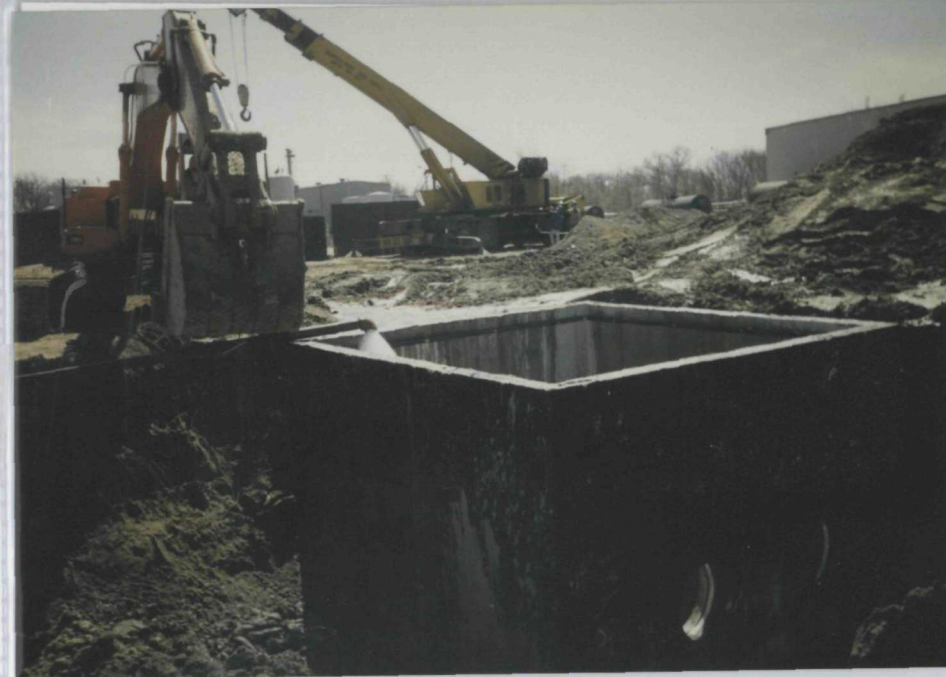
Description: Facing south. Filling water in the western settling tank to prevent it from moving during backfilling activities.

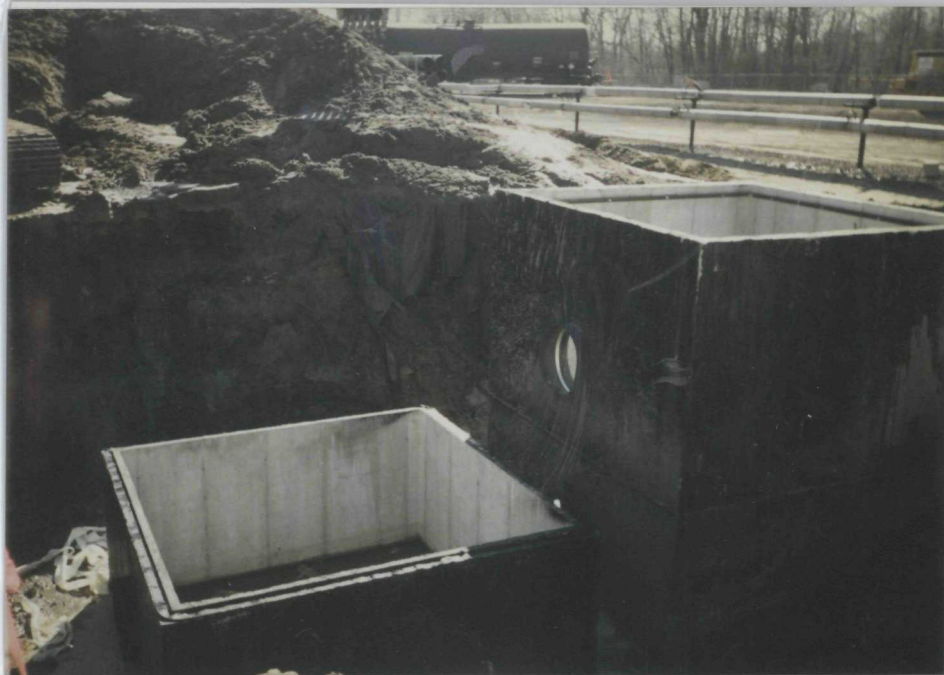
Site: American Chemical Services, Inc. RD/ERA  
 Proj. #: 71670.600  
 Roll: 2 Photo #: 89  
 Date: 04-02-97 Time: 1445  
 Photographer: Ashok Rupani  
 Description: Facing south. Bottom half of the central settling tank  
 being set in place.

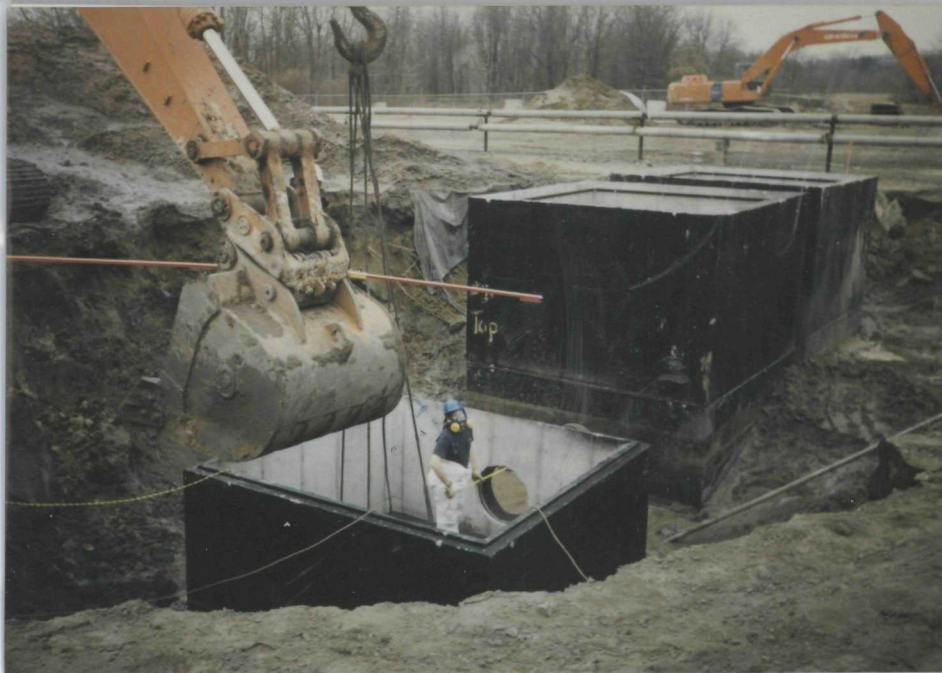
Site: American Chemical Services, Inc. RD/ERA  
 Proj. #: 71670.600  
 Roll: 2 Photo #: 93  
 Date: 04-03-97 Time: 1100  
 Photographer: Ashok Rupani  
 Description: Facing south-west. Setting the bottom half of the eastern settling tank in place.

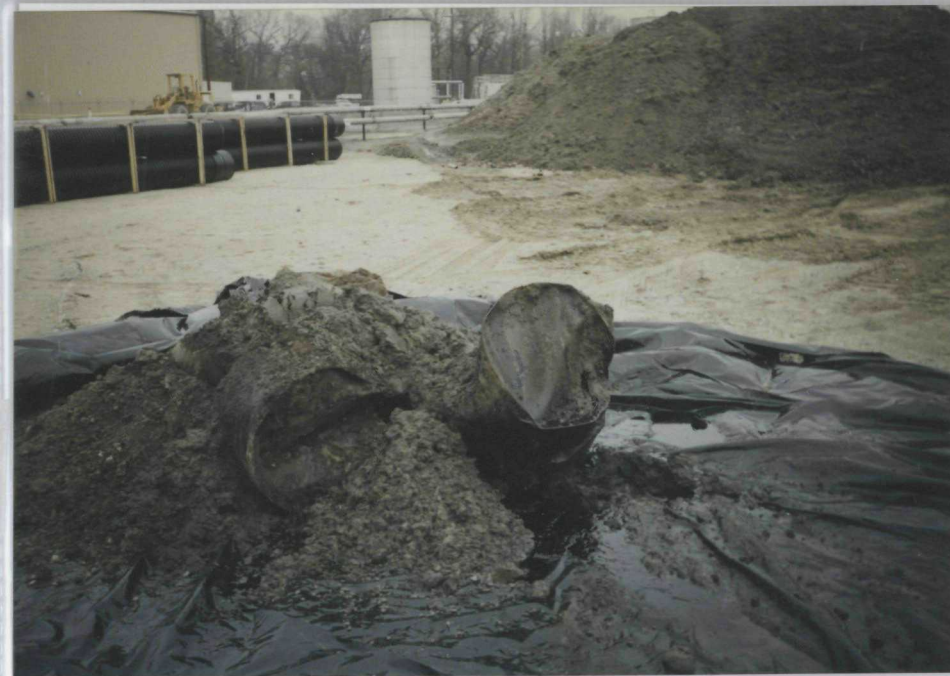
Site: American Chemical Services, Inc. RD/ERA  
 Proj. #: 71670.600  
 Roll: 2 Photo #: 94  
 Date: 04-03-97 Time: 1115  
 Photographer: Ashok Rupani  
 Description: Facing south. Some buried drums were uncovered while excavating for the eastern settling tank.

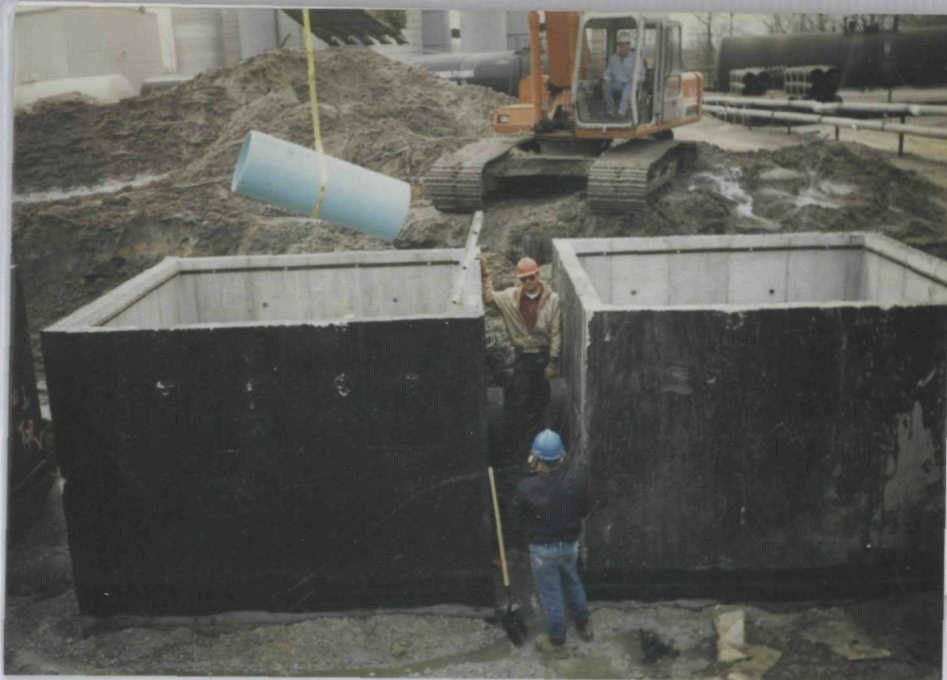
Roll: 2 Photo #: 97

Description: Facing south. Installing a connecting pipe between the western and the central settling tank.
